At the Pentagon, Thin Aerogel Insulation Improves Thermal Efficiency of Renovation by 23%

Flexible, thin aerogel insulation a perfect fit for envelope upgrades to solid masonry wall buildings

CASE STUDY

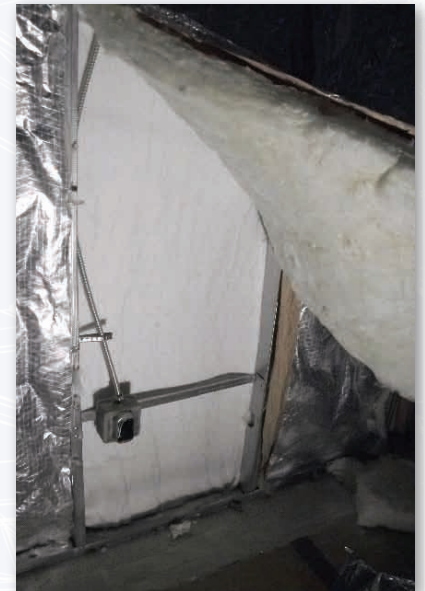
- Apply one layer of **Spaceloft®** (10 mm, 0.4") to the existing solid masonry wall behind the metal stud frame wall and new cavity insulation.
- Spaceloft insulation was installed with spray adhesive and insulation pins.

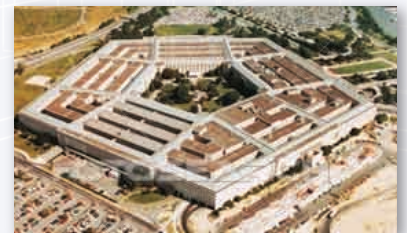
Pentagon Interior Wall Renovation With Spaceloft Insulation

Visible image

Infrared image
